**AVIATION INVESTIGATION REPORT**  
**A0000214**

**ENGINE FAILURE—FORCED LANDING**

**OTTAWA AVIATION SERVICES**  
**DIAMOND DA 20-A1 C-GOAS**  
**OTTAWA, ONTARIO**  
**03 OCTOBER 2000**

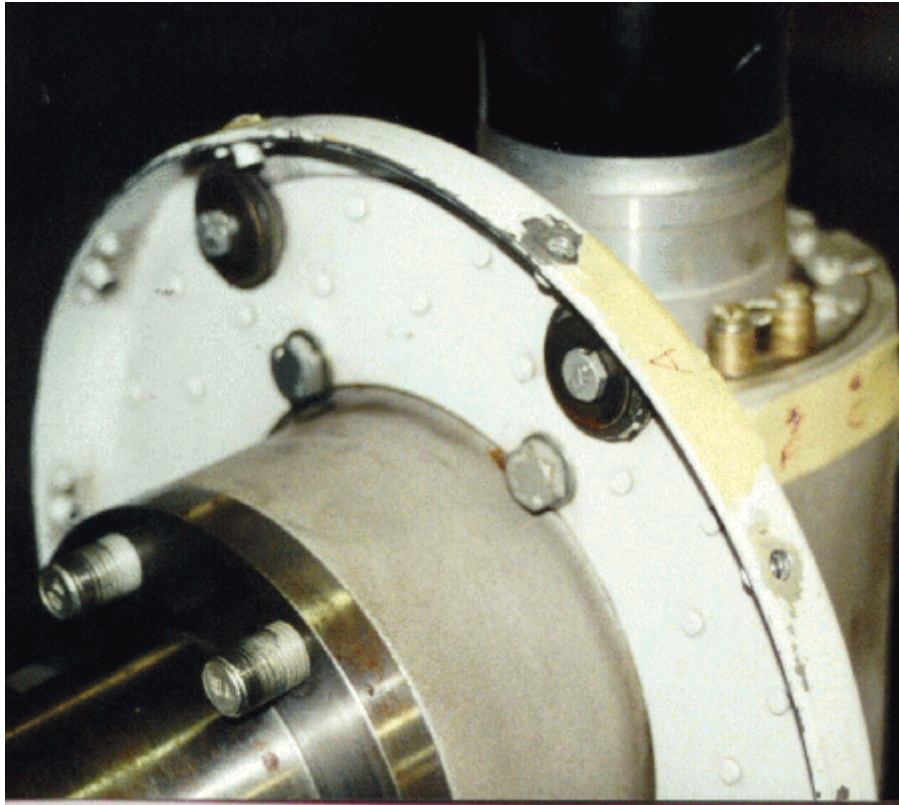
Figure 1 - Spinner bulkhead, showing lead weights behind the blade.

The propeller manufacturer's instructions for static and dynamic balancing call for the installation of AN 970-3 balancing shims mounted to the engine side of the spinner bulkhead. The total number of the balancing shims or total weight of the balancing shims in any one position was not to exceed six washers or 28 grams. The occurrence propeller had a combination of AN 970-3 balancing shims and lead washers installed on the spinner bulkhead behind the No. 2 blade (Figure 1). Additionally, there were four stacks of six AN 960-3 washers around the root of the No. 2 blade (Figure 2); this was not in accordance with the manufacturer's instructions.

The total weight of all the balancing weights attached to the No. 2 blade and the corresponding spinner bulkhead positions was 108 grams, whereas the maximum allowable weight was 56 grams. Furthermore, static and dynamic balancing of the propeller showed it to be 33 grams heavy on the No. 2 blade. Additionally, the dynamic balancing of the propeller should not exceed 0.2 inch per second at take-off rpm (revolutions per minute). When checked, the propeller was found to produce a vibration of 0.430 inch per second.

1. Three engines were replaced as a precaution against further defects.
2. Rotax engines are now operating on the recommended automobile fuel (mogas).
3. Propeller balance is now checked every 200 hours.
4. Oil sample analysis is now carried out in a more timely manner.

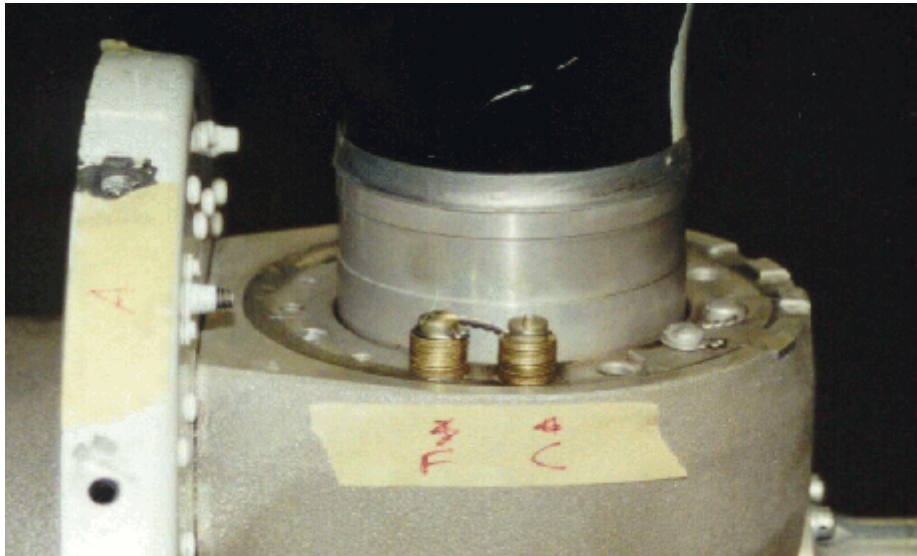
Figure 2 - Blade root, showing two of the four stacks of AN 960-3 washers.
